Landslide occurrence in East Timor

Melbourne Energy Institute
Technical paper series

June, 2011

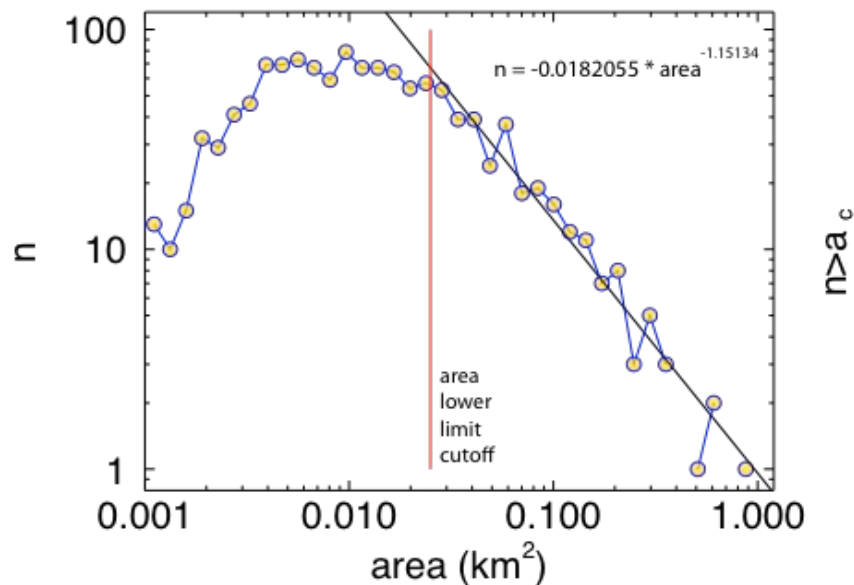
Figure 4.2: Power law relation between the number and magnitude of landslides in East Timor, where $n_{TOTAL} = 2005$ employing logarithmic bin widths ($\log_{10}w = 0.0782921$). Mapping method puts lower bound landslide number estimates at about $2.5 \times 10^{-2} \text{ km}^2$. Above this cutoff, a very clear power law trend is observable. Best fit straight line over this trend yields a gradient of -1.15134, which is equal to the exponent β in the following equation $n_c(A \geq A_c) = \kappa(A_c / A_r)^{-\beta} A_r (1)$. Kink in the upper end values of the histogram may be a mapping artifact or reflection of size discontinuity in mass wasting mechanics.

A landslide inventory of 2005 in East Timor compiled during this study has been demonstrated to show a negative power law relation between number and landslide area over two orders of magnitude ($\sim 10^2 - 10^0 \text{ km}^2$) for areas greater than $2.5 \times 10^{-2} \text{ km}^2$. This relation reflects a scale invariance of the total area affected of landslide, including the zone of deposition. The slope of the power law implies that the bulk of the erosional work is done by infrequent high-magnitude events. The highest spatial density of landslides was observed in areas with clay-rich units of the Synorogenic Melange and soft recent material of the Synorogenic Megasequence. These terrains exhibit distinct denudation landforms, with lithology and climate acting as the primary controls for landsliding, rather than fluvial incision and the development of critical hillslopes. Landslides in East Timor also occur in areas with high slopes ($>40^\circ$) in the central northern and southern highlands. Here unsustainable agricultural practices on steep slopes and torrential rains cause soil erosion and landslides.

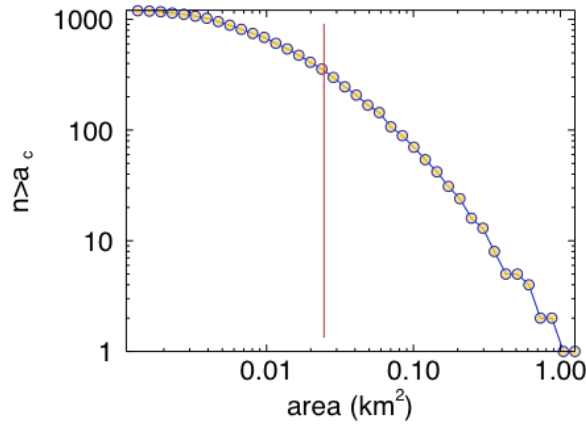
Figure 4.3: Number of landslides equal to or greater than landslide area employing logarithmic bin widths ($\log_{10}w = 0.0782921$) also has a power law relationship with a gradient of approximately -1.

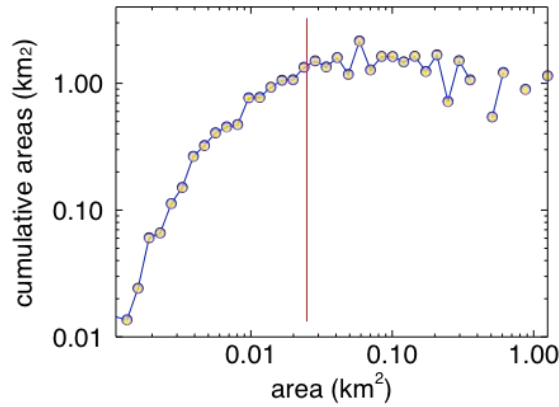
Figure 4.4: Relation between the cumulative areas and landslide area employing logarithmic bin widths of ($\log_{10}w = 0.0782921$), showing the lower bound cut-off at $2.5 \times 10^{-2} \text{ km}^2$. The plot illustrates that the cumulative areas of the many small landslides above the cut-off are of equal magnitude to the contribution of the few upper scale ones.

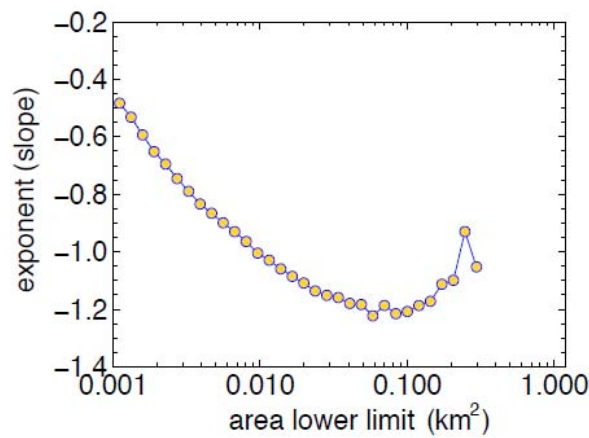
Figure 4.5: Power law exponent (β) illustrating the change of the exponent - the ‘roll-over’ effect – for areas below the lower-limit cut-off at $2.5 \times 10^{-2} \text{ km}^2$.

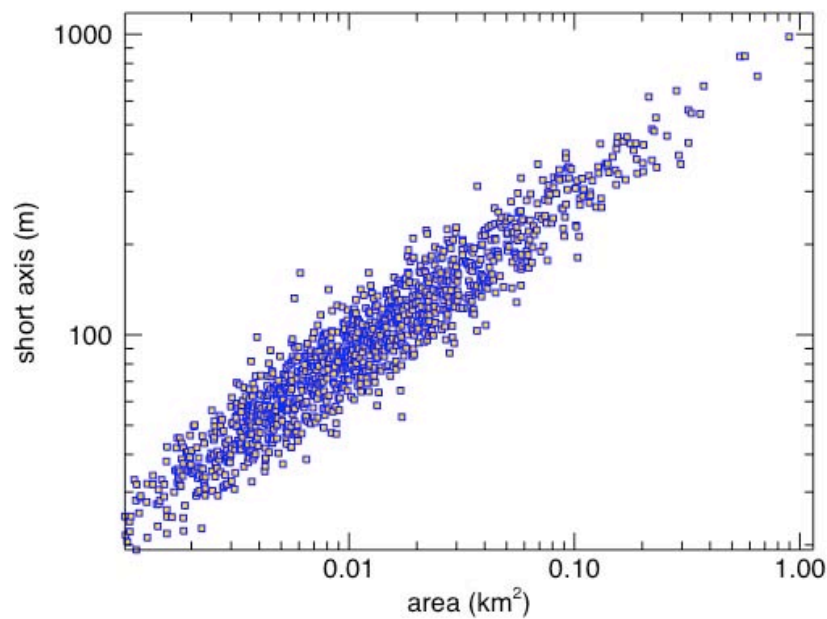
Figure 4.6: Relationship between landslide area and short axis of bounding rectangle (width of the landslide).

The geometry of the mapped landslides are approximately elliptical with an aspect ratio of about 3. A majority of the landslides were mapped in unconsolidated recent lithologies of the Synorogenic Megasequence and the clay-rich Synorogenic Melange, and have long runout distances. The relationship between the landslide area and short axis of a best fit bounding rectangle was plotted on a logarithmic axes (Figure 4.6). The short axis (width) is shown to be roughly equal to the square root of the landslide area.

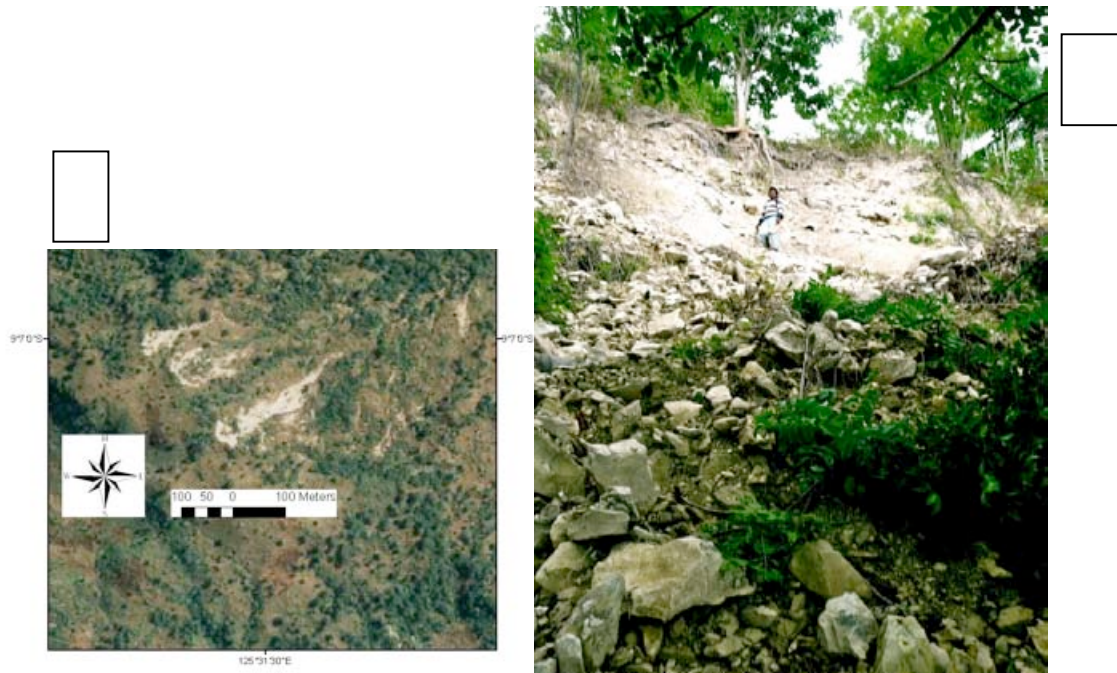
Figure 4.7: **A** Several deep-seated landslides in Cassa exposing white planktonic foraminiferal marls, 2001 aerial photo. **B** Visit to the site during the 2010 field season.

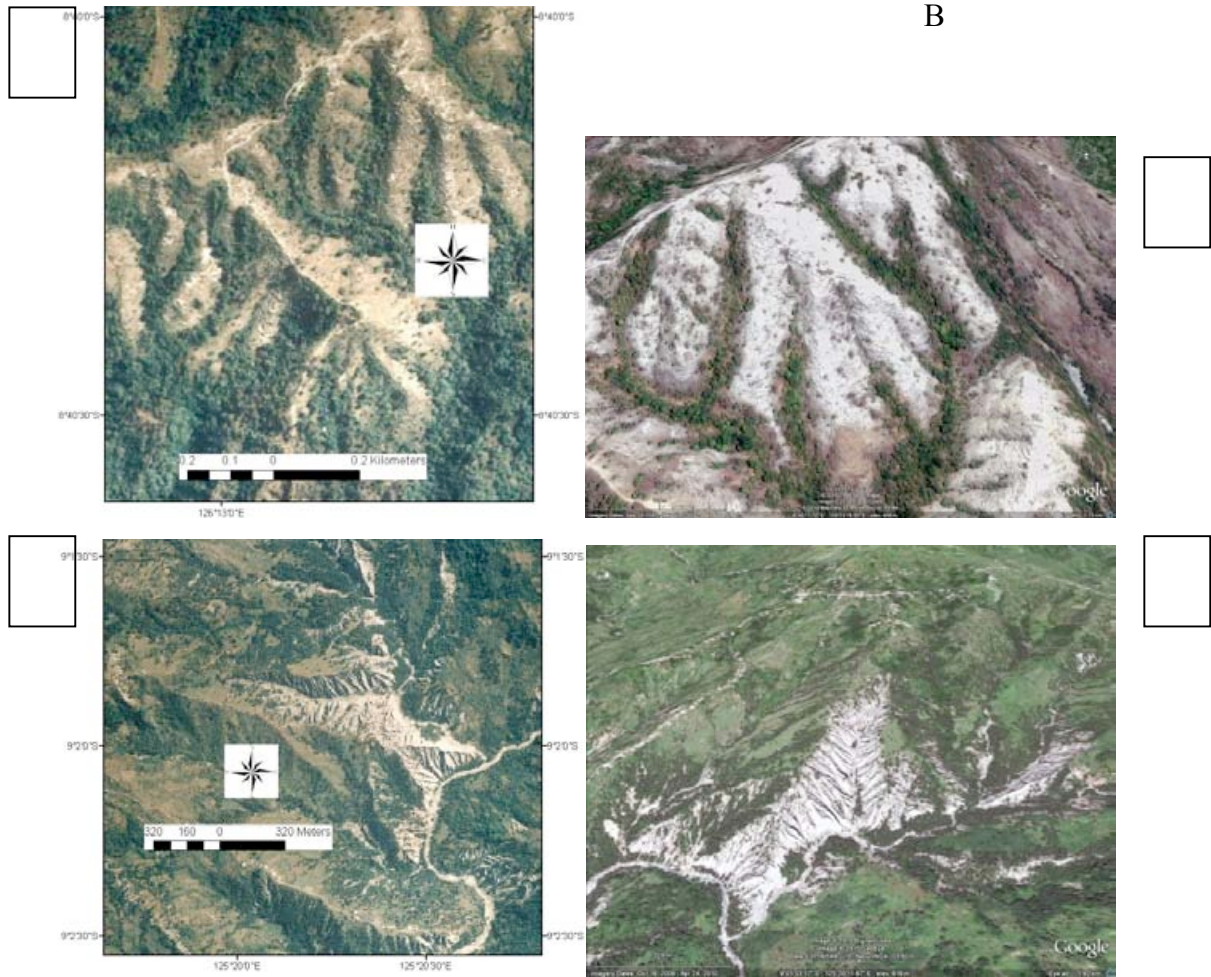
Figure 4.9: Distinct denudation landform of the Synorogenic Melange (Bobonaro Scaly Clay). A 2001 Aerial photo and B Google Earth© image of denuded hillslopes with parallel pattern type network developed showing distinct soil creep. C 2001 aerial photo and D 2010 Google Earth© image, Bobonaro district. The slopes are denuded and the clays of the hillslope are dissected by a dense network of inclined to steeply inclined rills and V-shaped gullies, separated by narrow, sharp crested interfluvies.

signature (Figure 4.9). Intense and prolonged precipitation plays a major role as both triggering new failures and in the reactivation of landslide bodies.

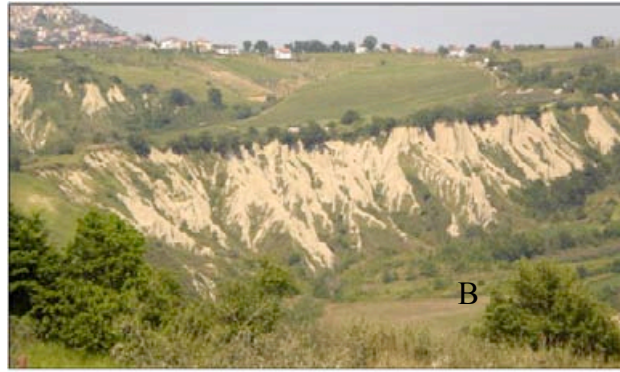
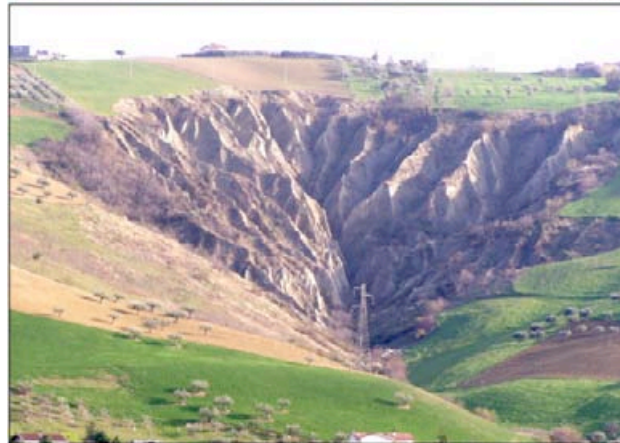
Figure 4.10: Examples of *calanchi* basin with **A** dendritic and **B** parallel pattern drainage network. These denudation landforms Taken from Buccolini & Coco (2010).

These landforms and lithological controls on landslide susceptibility are comparable to the *calanchi* of central Italy (Figure 4.10). The *calanchi* are a distinct denudation landform of central Italy, where the high gradient of the slope and the low permeability of the lithotypes comprise to reduce infiltration of water favouring rapid surface streamflow, with the consequent cutting of dense drainage networks.

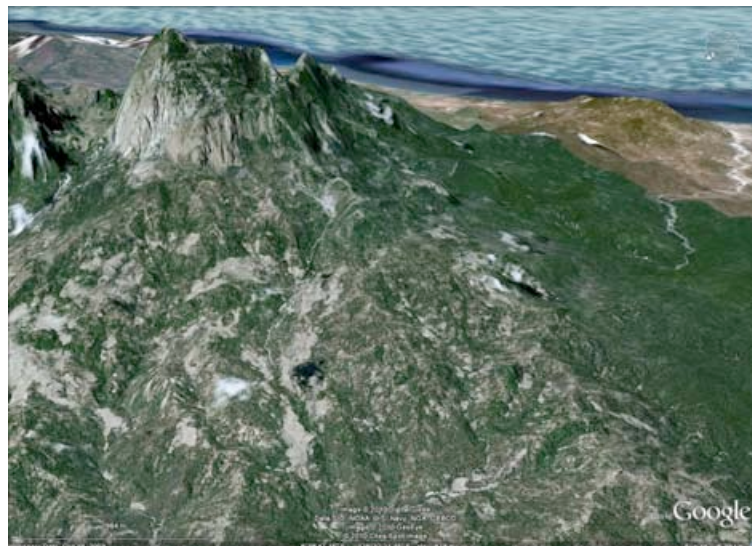
Figure 4.11: 2010 Google Earth © image of Bualale landslide looking south-east.

The largest mapped landslide in the inventory is located in the hamlet of Bualale on the night of 16 March, 2000 (Figure 4.11). More than 250 people (50 families) were affected, and the landslide destroyed the only road and bridge to the nearby village of Lassarolai. The distance from the main scarp to the toe of the landslide is 4,330 m. Initial failure occurred in sandstones and clays of the Synorogenic Megasequence and Melange. Lateral slides occurred as the major landslide moved down slope. These slides are still active. Comparison between the aerial photo taken in 2001, a year after the initial failure, with the recent 2010 Google Earth© image shows a five-fold increase in the affected area and a significant full flowing stream developed (Figure 4.12).

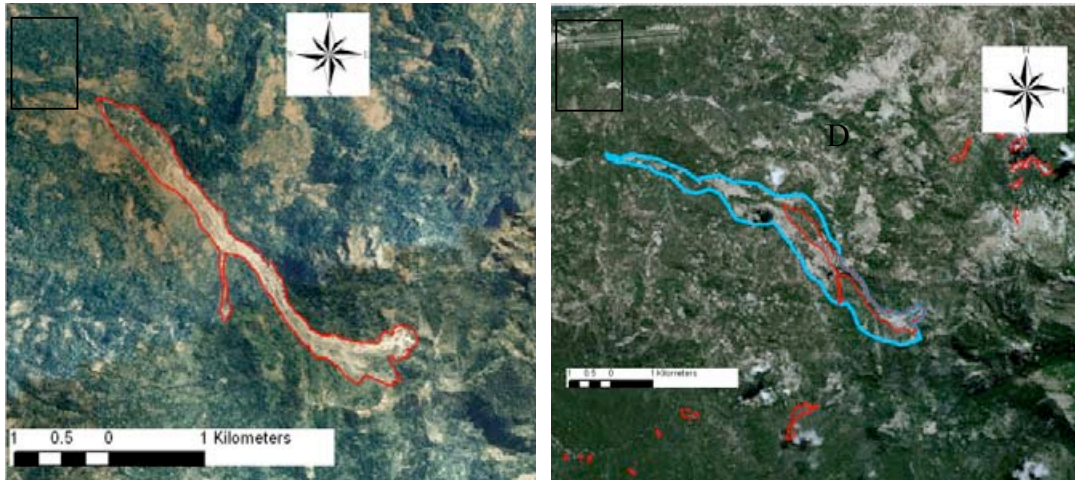
Figure 4.12: Change in extent of affected landslide area from 1.146 km² in the 2001 aerial photograph **A**, to 5.496 km² in the 2010 Google Earth© image **B** .

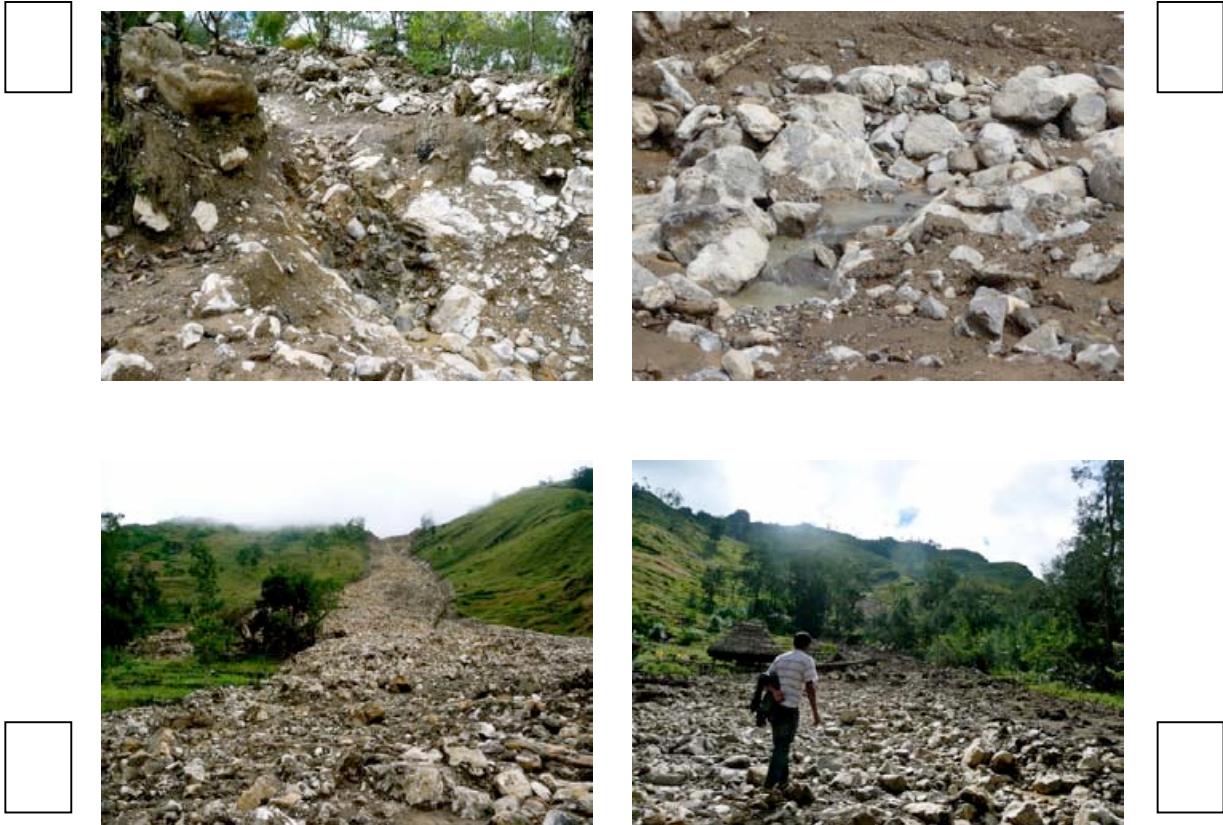
Figure 4.13: Landslide in the hamlet of Aituto which occurred in June during the wet season after three consecutive days of intense rainfall. **A** Landslide deposit comprising of angular siltstone and calcilutites boulders and gravels. **B** Surface runoff flowing over the landslide deposit. **C** The landslide scarp is located on the south side of the Aituto Anticline, with the accumulation zone diverging into two distinct flow tracks. **D** Walking up the western flow track of the landslide.

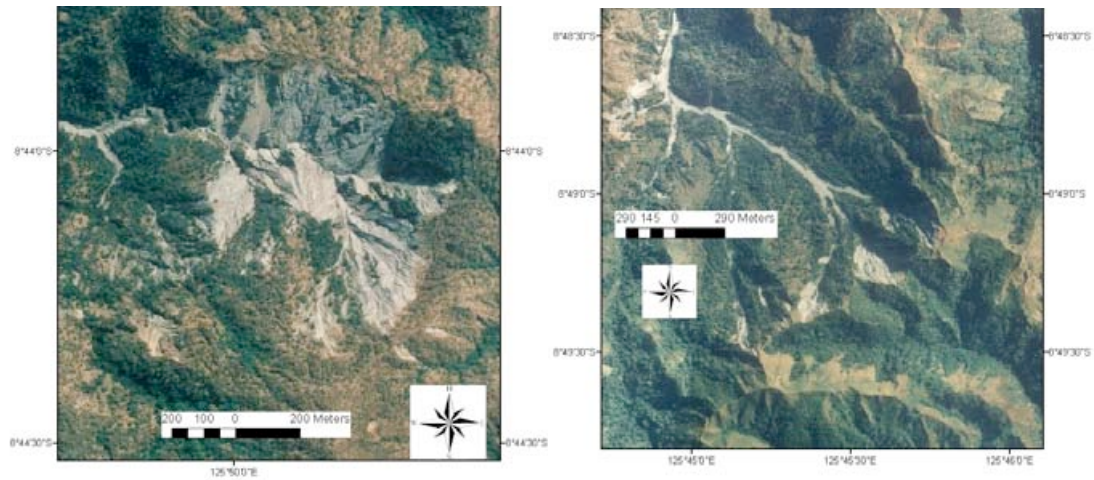
Figure 4.14: A Deep-seated landslide with arcuate landslide scarp in the Banda Terrane (Lolotoi formation Audley-Charles, 1968) Manatuto district. B Circular deep-seated scarps in the Banda Terrane, Manufahi district.

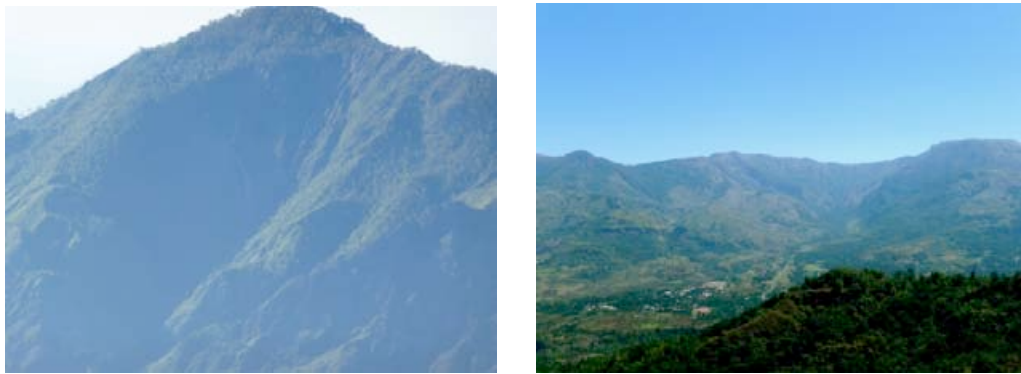
Figure 4.15: A Downward concave morphology of a landslide headscarp on the north facing flank of the Cablac mountain range. B The amphitheatre shaped headwaters of the 'Ainaro collapse' north of Ainaro villa, whose geometrical evolution is a result of landsliding.

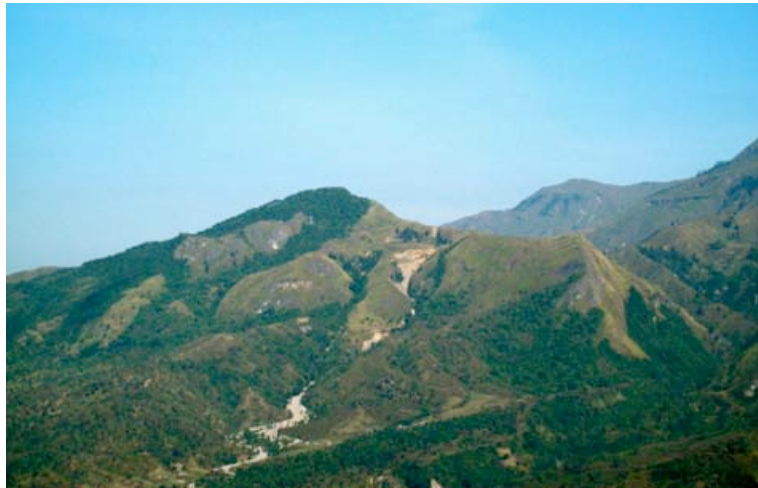
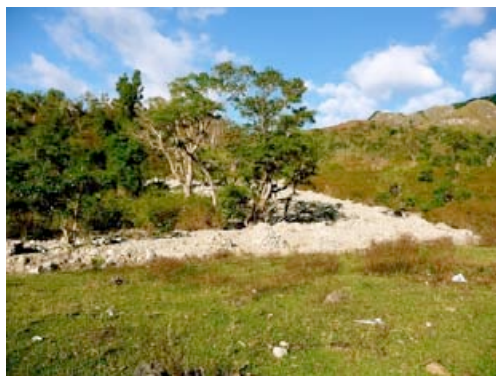
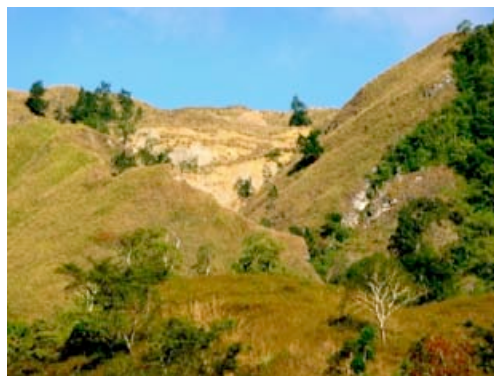
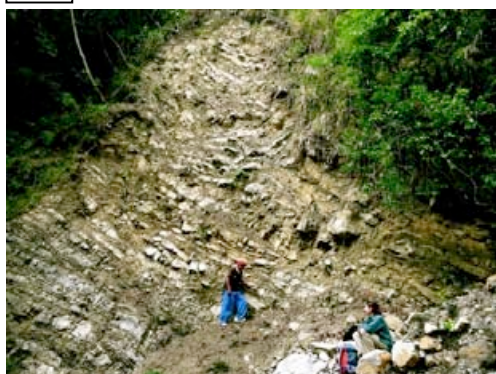
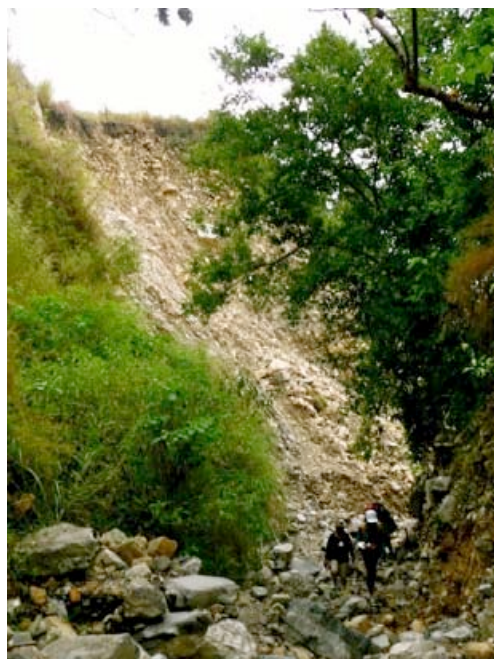
Figure 4.16: **A** Contributing landsliding mass from Mount Buisaralao is outpacing the ability of the Sigé river to remove the material. **B** Alluvium of Sigé river comprising bioturbated siltstones. **C** and **D** Deep-seated landslide scar in Mount Buisaralao exposing bedrock geology of the hillslopes comprising predominantly of bedded siltstones and limestones. **E** Sigé river incising through landslide deposit forming steep debris bound terraces.

Mount Buisaralao in Ainaro is an excellent example summarising catchment expansion via landsliding (Figure 4.16). A large landslide from this hillslope deposited a large amount of debris on top of one of the older 'Ainaro collapse' debris terraces and initiated the Sigé river, which has incised both the landslide scar and deposit forming steep debris bound terraces. Stream entrenchment of the Sigé river has promoted valley-floor lowering through the landslide debris and into bedrock, exposing bedded silstones and sandstones.

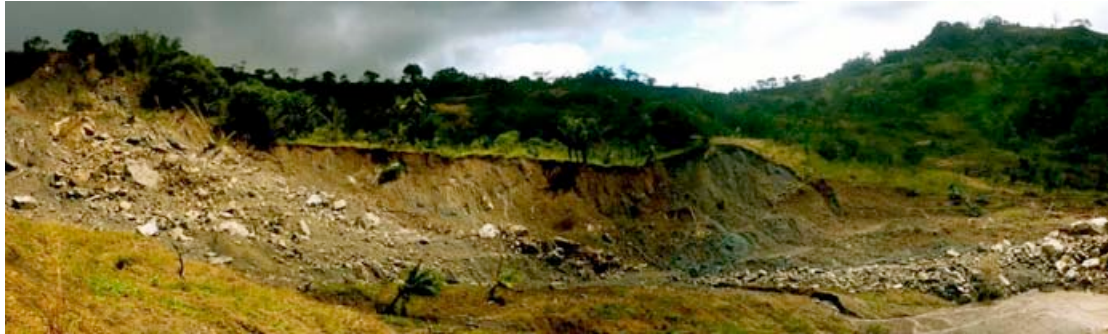
Figure 4.25: Image of Lacalio landslide and exposed scarp facing west, scarp length 180m.

km². The area affected by the landslide had previously been used for subsistence agriculture. The steep hill slope had terraces cut into it to cultivate rice paddies and had been subject to annual burning to reduce excess plant material and control disease, pests and weeds. The adjacent hill slope has dense vegetation that, according to local inhabitants, has been relatively unchanged for at least 70 years. Studies of this landslide can give unique and important insights into possible underlying causes of landslides in the district, in particular, highlighting any lithologic and/or structural controls that could influence where the slides occur.

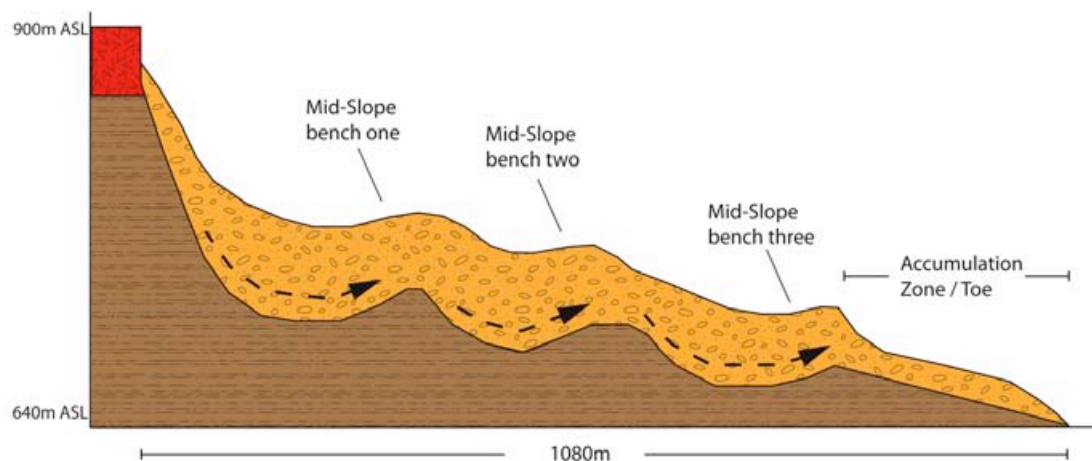
Figure 4.26: Schematic view of the profile of the Lacalio landslide. The profile shows the surface morphology of the landslide material (orange) and the likely contacts with the underlying mudstone (brown) and volcanoclastics (red). Geometrically the side has at least three mid slope benches with segments tilting back towards the headscarp as the blocks rotate around axes.

The landslide appears to have been deep seated extending below the soil and colluvial layers into the competent bedrock. The colluvium consists of a mixture of fine particles of mud and bedrock clasts ranging in size from sand to a maximum clast size approximately 20m by 20m (Figure 4.32).

rupture, glide plane, of this type of slide is curved concavely upward about an axis, which lies sub-parallel to the ground surface across the landslide. The effect of this rotation can be seen in profile of the geometry of the slide. The rotated blocks create a series of backwards tilting midslope benches and internal scarps. The distal end of the slide colluvium sits in a large accumulation zone or toe. Some areas within the landslide have remained relatively intact with some vegetation near to growth position. The landslide concentrates and channels precipitation and has created large areas of alluvium deposits and sag ponds. The channelling of the water has created a new stream system down the northwest side of the slide and has diverted a separate river along the east side (Figure 4.27). These drainage systems transport sediment from the landslide into the local river systems.

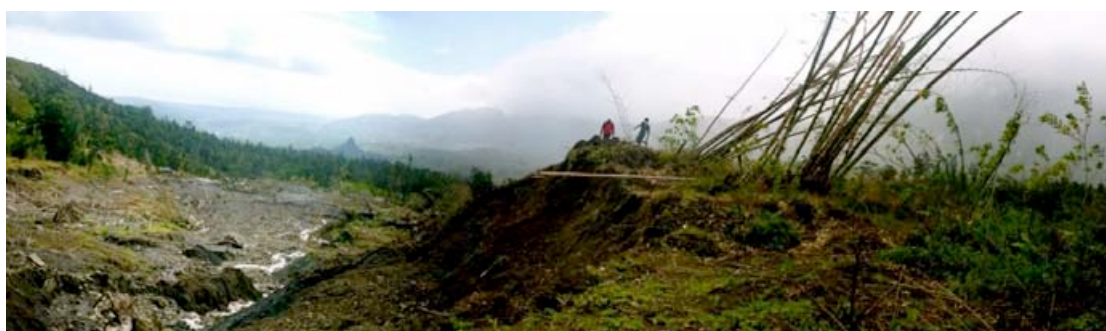
Figure 4.27: Image of the toe of the landslide facing northeast. Showing the last of the mid slope benches with a backwards tilt of 10° south followed by a large scarp. Areas of large alluvial deposits with a newly formed stream can be seen in the left corner of the image. Upright vegetation also with backwards tilt essentially ‘surfing’ the slide. Note people at scarp edge for scale.

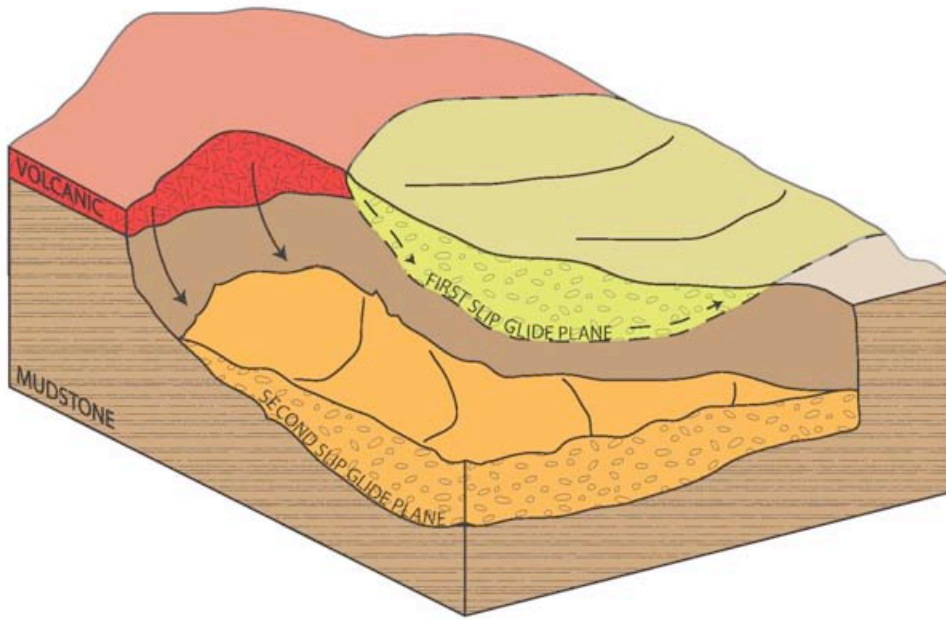
Figure 4.28: Block diagram representing multiple slips. The scarp exposed by the second slip shows a series of bedded mudstone overlain by the volcanoclastics. The scarp also exposes a colluvium deposit most likely created by an earlier slide. The glide plane between the first slip and underlying mudstone is visible.

The cross section also reveals a possible deposit from a previous landslide on the same area, comprising angular clasts in a mud matrix. The contact between the colluviums deposit and the underlying mudstone bedrock (Figure 4.28) indicates that the previous slide also had a rotational component.

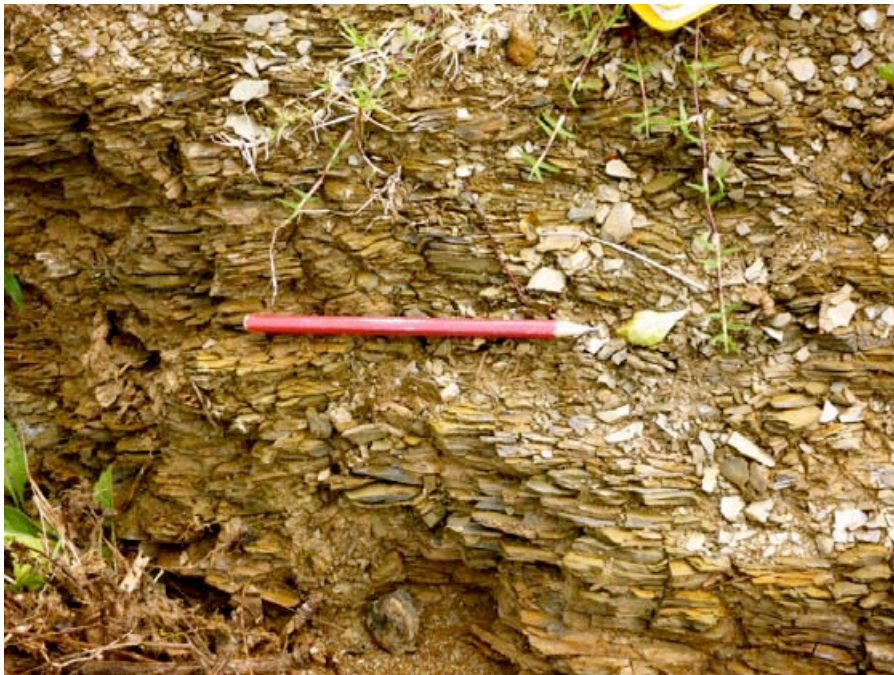
Figure 4.29: Bedded mudstone bedrock, the main component of the landslide colluvium.

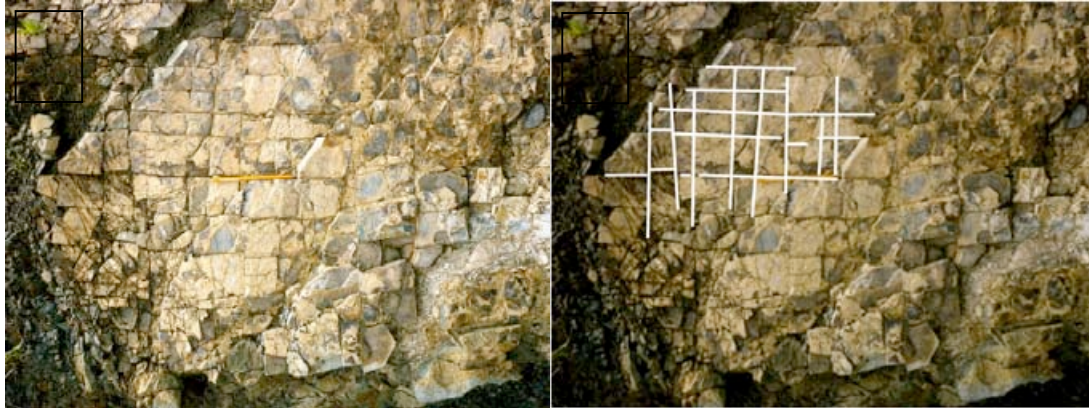
Figure 4.30 A & B: Jointing in the volcanoclastic bedrock in the headscarp. Note: yellow pencil for scale.

Jointing (Figure 4.30) and faults along the scarp of the volcanoclastics indicates that the area has undergone previous deformation. The volcanic bedrock appears to have preferentially separated along one of the previous fault planes along the west side of the head scarp (Figure 4.31). Kinematically the movement on the fault plane is predominantly dextral strike slip with a minor normal component determined by the striations and slickensides on the exposed surface. The movement on this fault is in opposition to the movement on the more recent landslide dismissing the possibility that these markings are related.

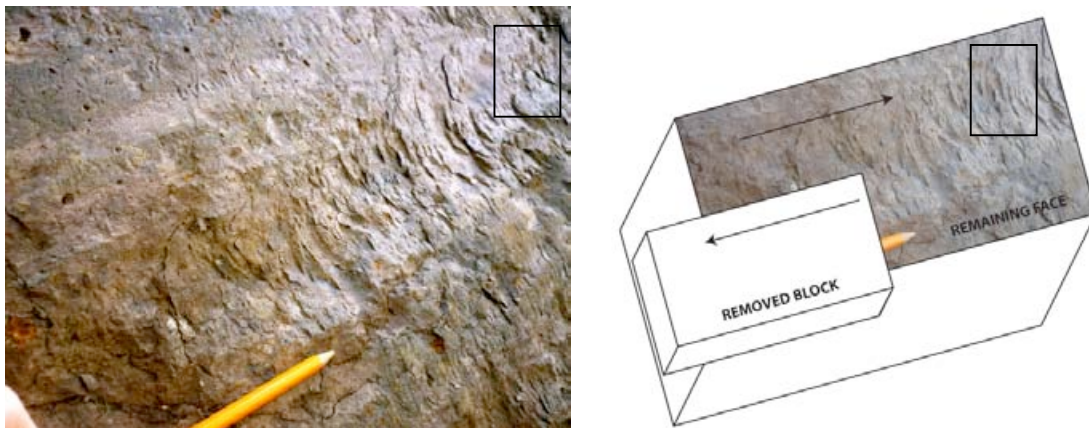
Figure 4.31: A Image, facing west, shows dextral strike slip surface of the remaining block of volcaniclastic bedrock in the headscarp orientation of striations and slickensides visible. **B** Block diagram showing fault kinematics; strike 007/dip 72°E.

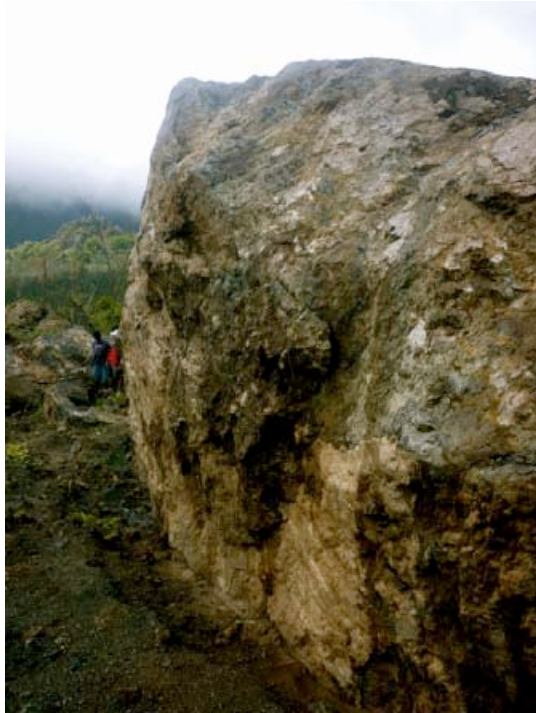
Figure 4.32: Largest volcaniclastic clast in the landslide material (20 m x 20 m) with calcium carbonate.

Calcium carbonate deposits were found coating some of the large volcanoclastic clasts in the slide (Figure 4.32). Precipitation of this material suggests that prior to the landslide, fractures or cave like features existed in the bedrock allowing percolation of water. The presence of these features is likely to have also influenced the location at which the bedrock preferentially separated during the slide.

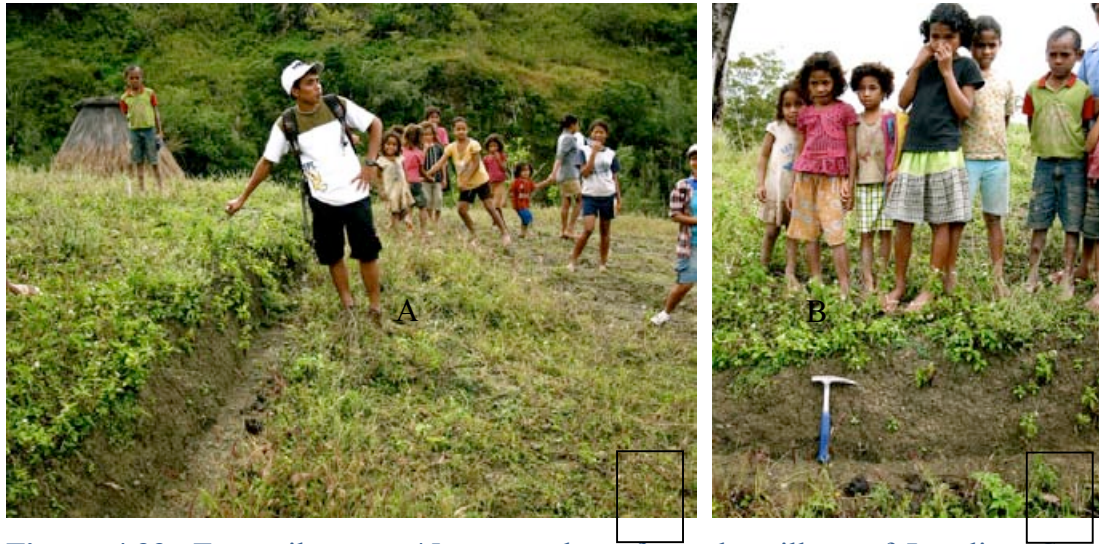
Figure 4.33: Top soil scarp, 45 cm, upslope from the village of Lacalio. Scarp appeared during the same heavy precipitation that occurred in May 2010, which triggered the Lacalio landslide. Photos taken by M. Quigley (2010).

The scarp of greatest concern is located approximately 280 m north west from the landslide and offsets the regolith layer by 45 cm (Figure 4.33). The scarp strikes 350° and dips 72° towards the east. An outcrop near the scarp shows the bedrock under the regolith layer to consist of the same weak mudstones found in the bulk of the landslide. If this scarp is an early indicator of a mass movement event it has the potential to be devastating due to its close proximity to the village of Lacalio. The village consisting of many personal dwellings is located less than 20 m away on the slope directly below.

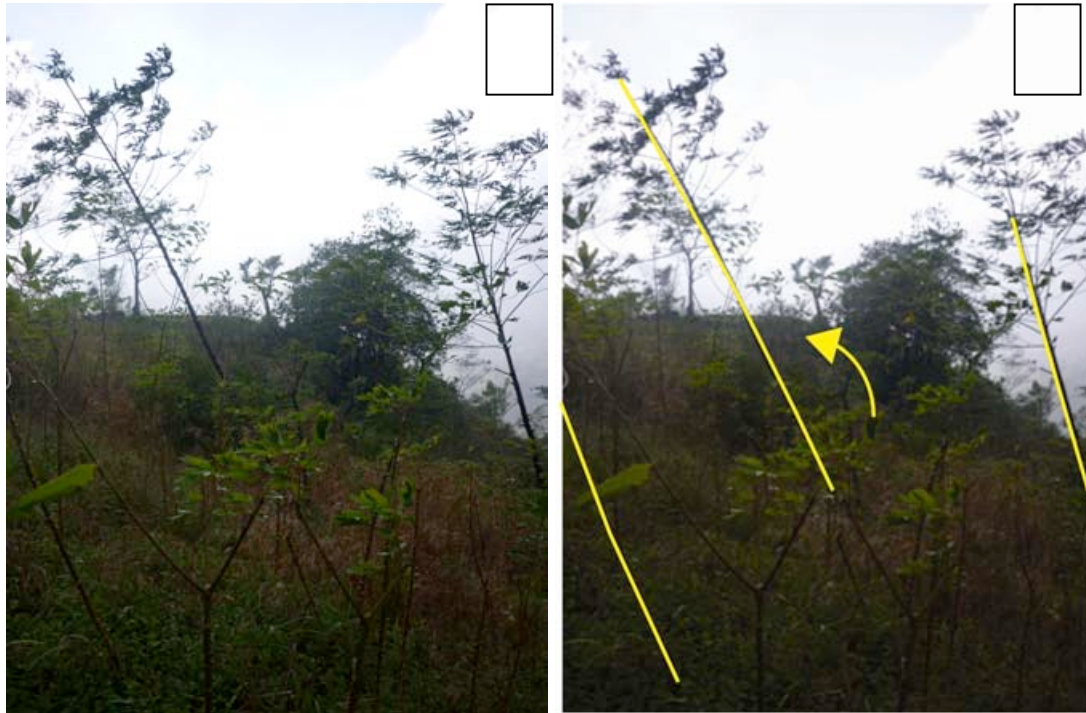
Figure 4.34 A & B: Older trees tilting back into the slope due to creep of soil during their growth.
